# D.T3.2.2 ON-SITE ENERGY AUDITS - CLASSROOMS

Version 1  
02 2019

## I. Building #1 SP 61 (ul. Białobrzaska 27, 02-340 Warszawa)

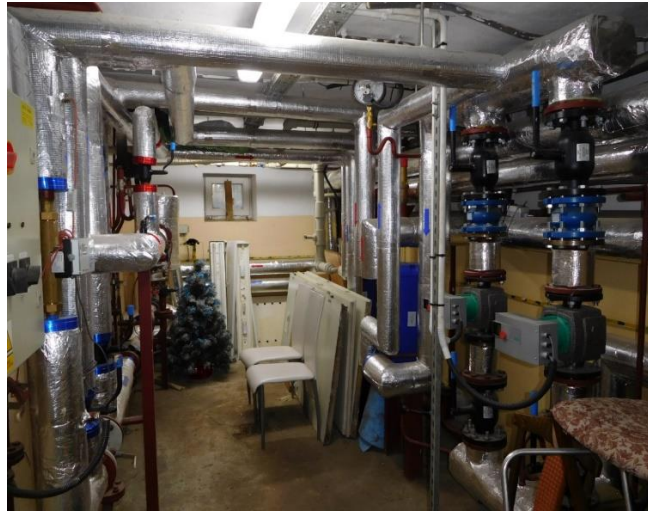
*Figure 2 Heating source in the building*

The heating source in the building is an insulated heat exchanger with weather control. The designed heating load for the building according to documentation is 0.291 GJ/h (0.338 MW), however the currently ordered power is set to 0.345 MW for the heating and 0.058 MW for the domestic hot water. Water is the working medium in the system. Water is the heating factor in the installation. The heat exchanger station powered by the district heating is insulated, so according to [1] its efficiency equals 99%.

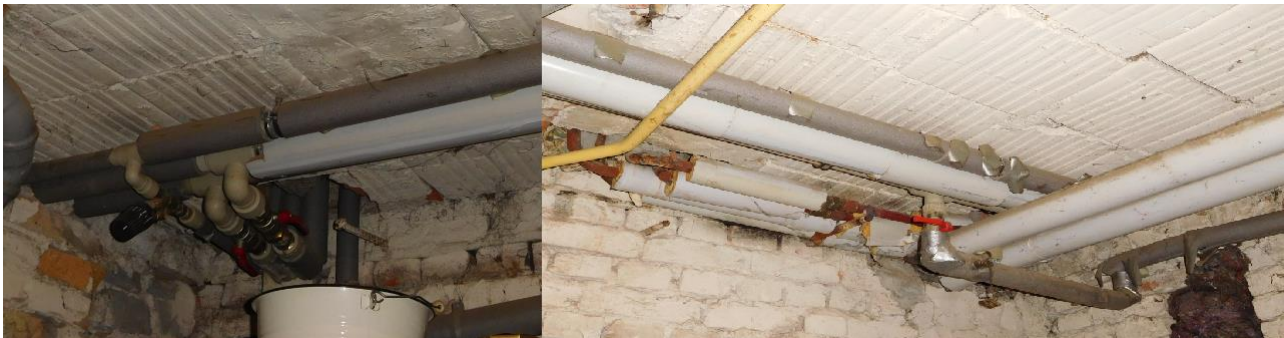
*Figure 3 Insulated pipes*

The insulation of the heat distribution system in the unheated zones is in a poor condition, many parts of pipes are lacking a thermal insulation. According to [1], the overall equals the overall system efficiency equals 90%.

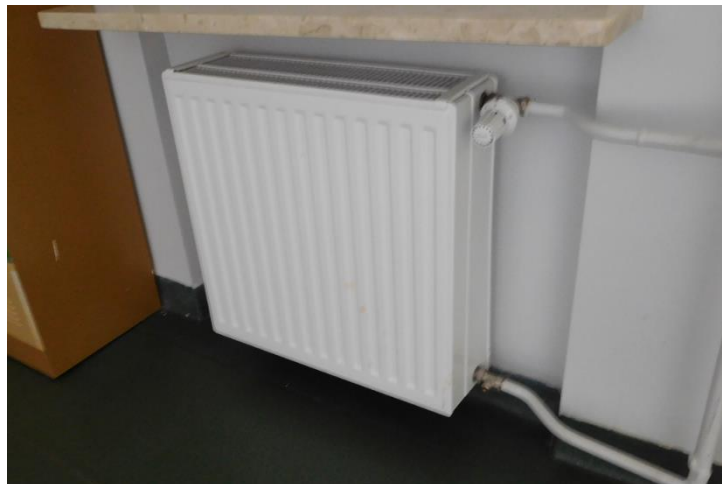
*Figure 4 Water convectors with thermostatic valves*

Heat convectors in the building are in good condition. They are equipped with thermostats. Convectors are mostly located in the niche under the windows, following the Polish construction requirements. According to [1], the overall system efficiency equals 89%.

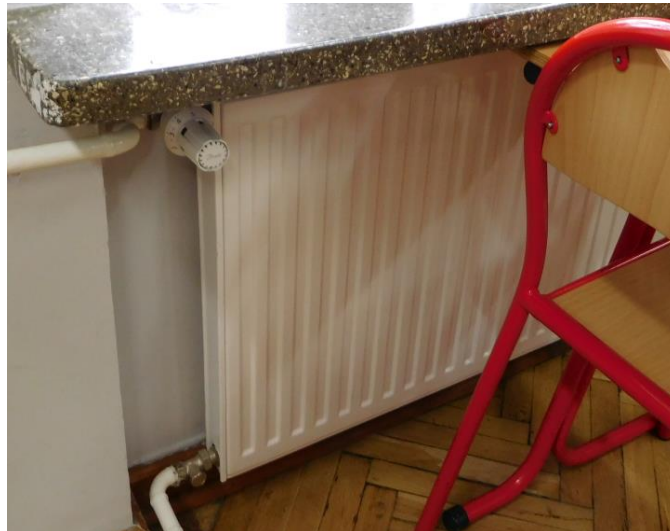
*Figure 5 Convectors in classrooms*

Water convectors in classrooms are the same as in the rest of the building, including thermostats. Temperature regulation in classrooms according to information gained during the audit is problematic and thermal comfort is not preserved. During cold days convectors do not supply enough heat to heat cold air coming through leaky windows. Convectors in classrooms are located in the niche under the windows, following the Polish construction requirements.

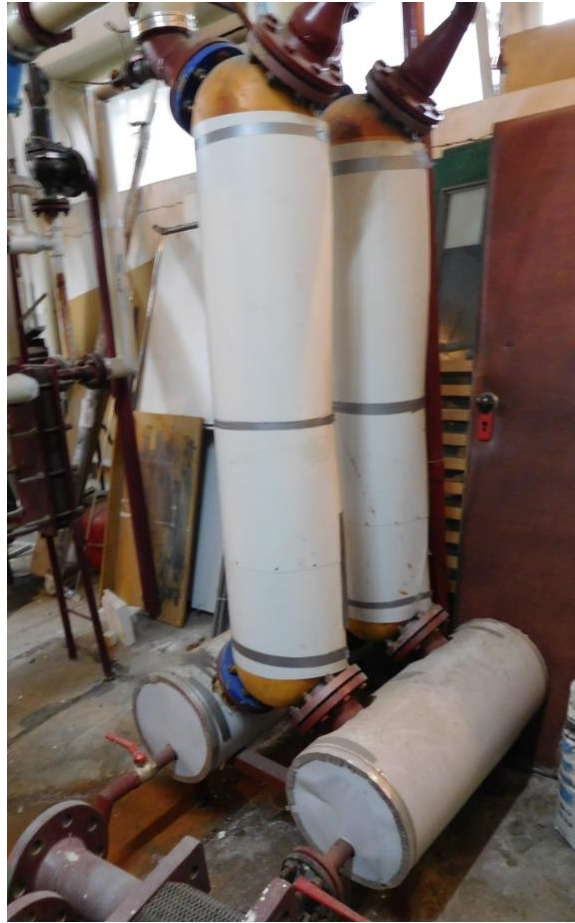
*Figure 14 Heating source in the building*

The heating source in the building is a double traditional heat exchanger “JAD” type with a weather control. The heating load for the building is 562 kW. Water is the heating factor in the installation. The heat exchanger station, powered by the district heating, is insulated, so according to [1] its efficiency equals 99%.

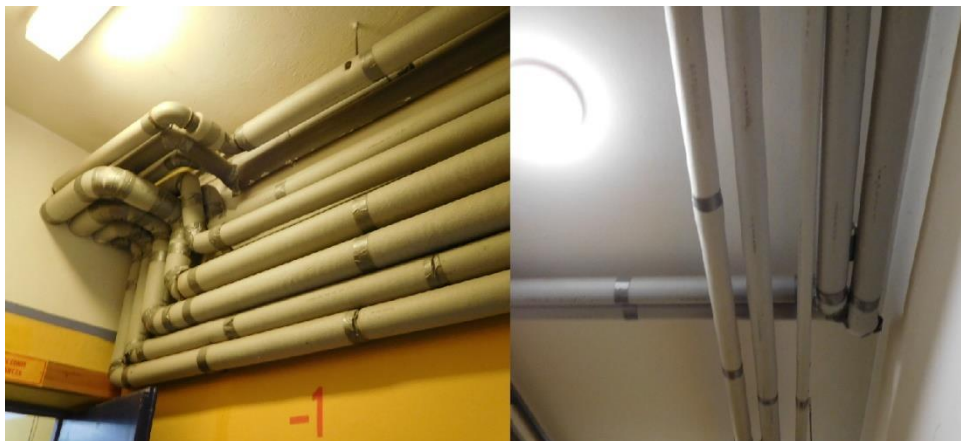
*Figure 15 Insulated pipes*

The heat exchanger cooperates with the insulated distribution system, providing heat for the covering central heating and domestic hot water in the building. The insulation is maintained in very good condition. Basement where the heating source is located is also a heated space. According to [1] the system efficiency equals 96%.

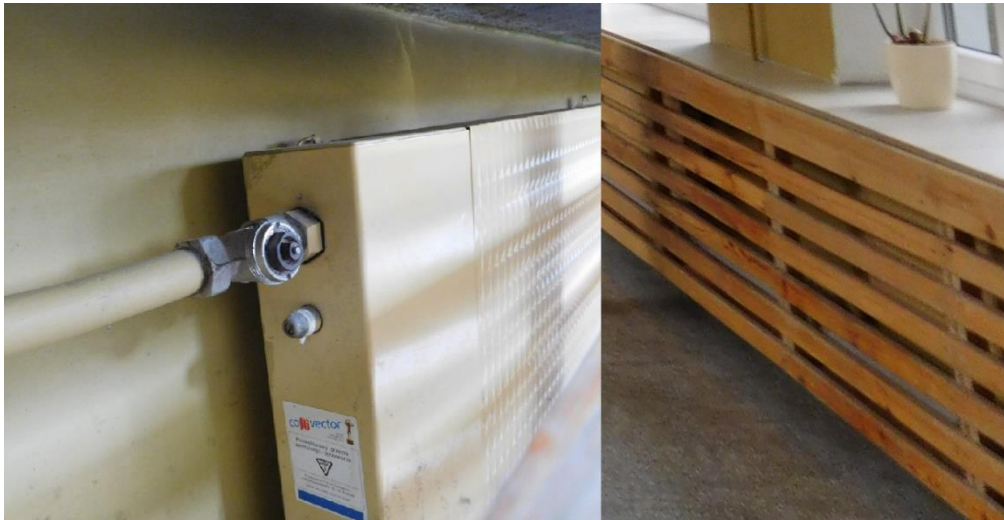
*Figure 16 Plate heaters in the building*

order to not allow kids to get burn when the system is working. This however decreases the efficiency of radiant heating of plate heaters and may be cause of decreased efficiency of distribution in the system. Around  $\frac{3}{4}$  of convectors are without thermostats. According to [1] system efficiency equals 77%.

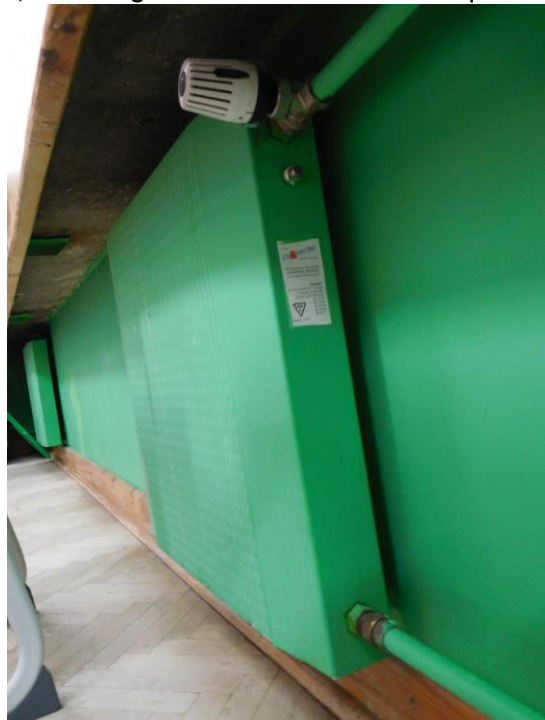
Water convectors in classrooms are the same as in the rest of the building. Some of them are equipped with thermostats. In classrooms there are no wooden boards. Temperature regulation in classrooms according to information gained during the audit is not good and it is usually cold in classrooms. Convectors are located in the niche under the windows, following the Polish construction requirements.

*Figure 17 Convectors in classrooms*

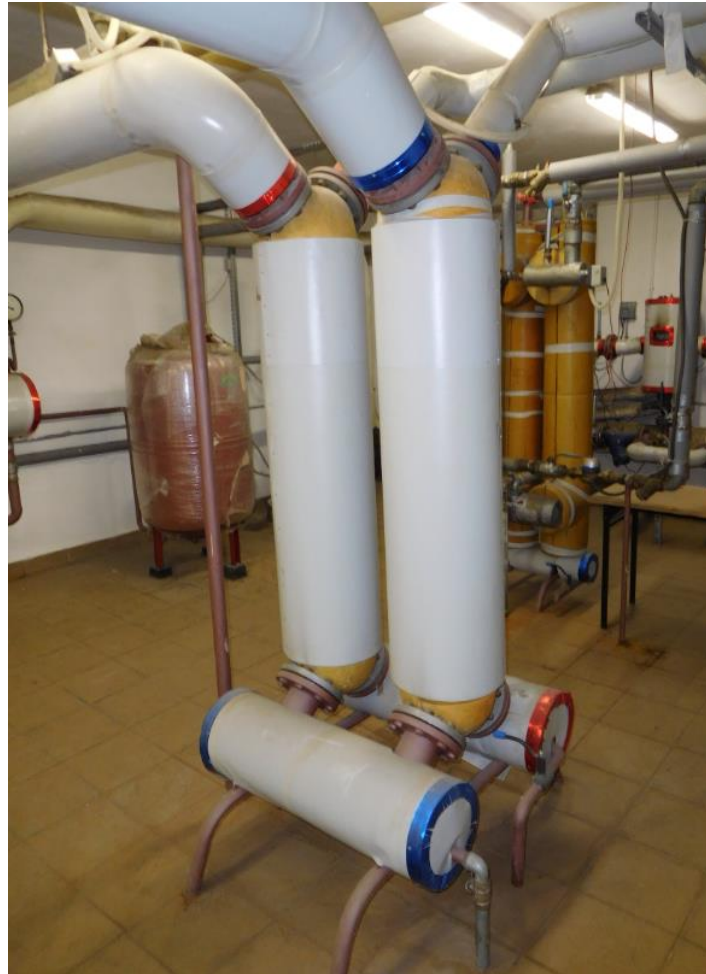
*Figure 22 Heating source in the building*

The heating source in the building is a traditional heat exchanger “JAD” type with weather control. Heating load for the building is 677 kW. Water is the heating factor in the installation. The heat exchanger station powered by the district heating is insulated, so according to [1] its efficiency equals 99%.

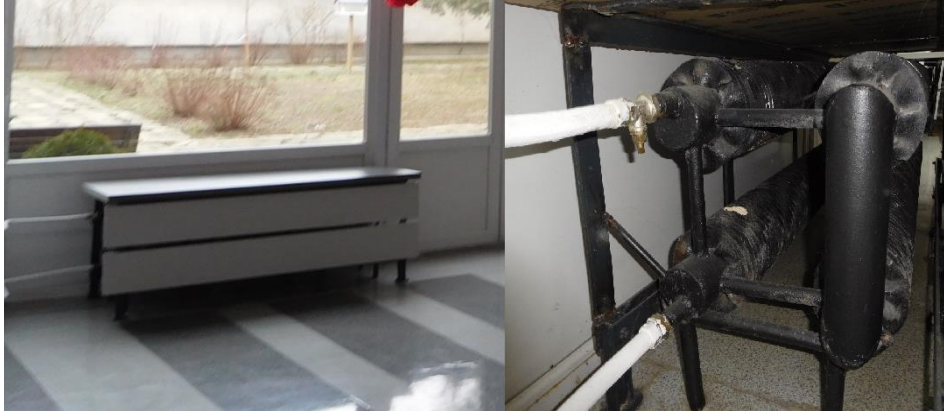
*Figure 24 Pipe heaters in the corridors*

Heaters have not been replaced since the building had been built. They are mostly located in the niche under windows, following the Polish construction requirements. In the building there are mainly pipe heaters and several iron ribbed convectors in the corridors that are usually not equipped with thermostats. Convectors in the corridors are covered with wooden boards which due to safety issues, in order to not allow

kids to get burn when the system is working. This, however, decreases the efficiency of radiant heating of plate heaters and may be cause of decreased efficiency of the distribution system. The most of convectors are not equipped with thermostats. According to [1] the system efficiency equals 77%.

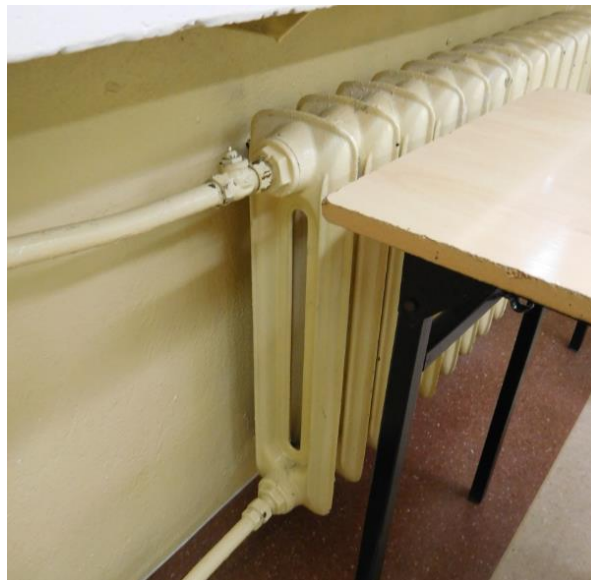
Radiators in classrooms are old traditional iron ribbed radiators without thermostats. There is only one central weather regulation in the heating source, so the only possible way for controlling the temperature in classrooms is to open the windows, which is usually done in order to improve the thermal comfort in the classrooms. Radiators are located in niches under the windows, following the Polish construction requirements.

*Figure 25 Iron ribbed convectors in classrooms*

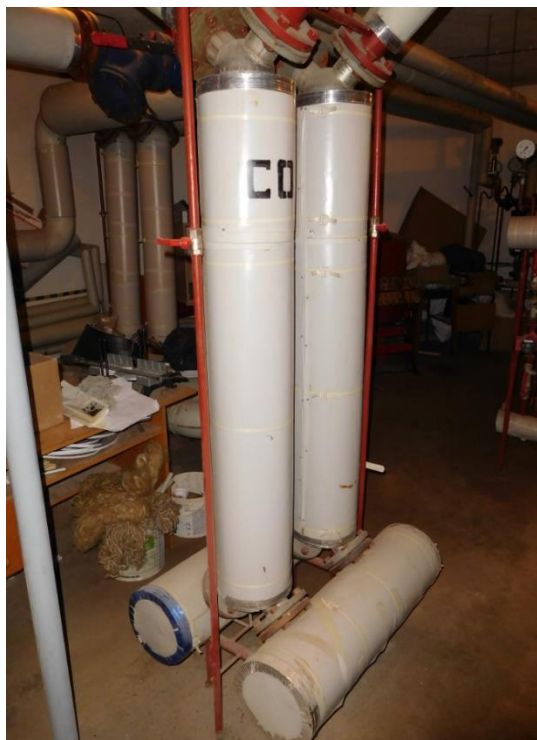
*Figure 33 Heating source in the building*

The heating system for domestic hot water is equipped with an accumulation tank. Due to the accumulation tank installed in the system, its total efficiency equals 65%, according to [1].

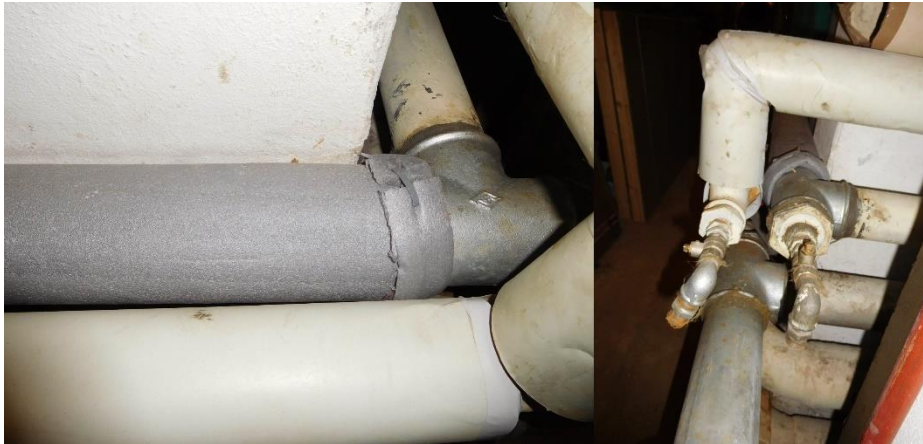
*Figure 34 Insulated pipes*

The heat exchanger cooperates with the insulated distribution system, covering central heating, domestic hot water and technological heat for the building. The insulation is in a poor condition. A basement where the heating source is located is a heated space. According to [1], the system efficiency equals 96%.

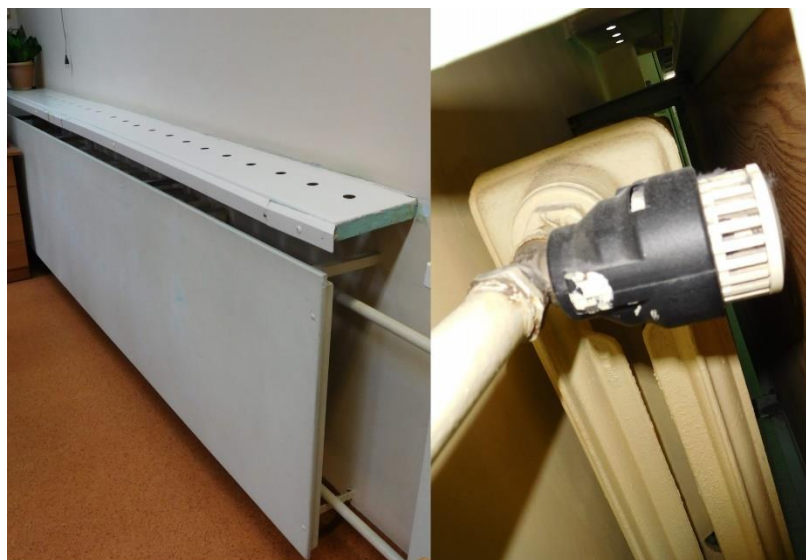
*Figure 35 Water convectors with thermostatic valves*

The heat distribution system in the school is original as designed. There are mainly iron ribbed convectors installed in stage I and II, plate convectors in stages III and IV, and some pipe convectors on corridors and in the canteen. The most of them are equipped with thermostats. Many of the convectors are covered with huge wooden plate which is done for safety issues in order to not allow kids to get burn when the system is working. This however decreases the efficiency of radiant heating of plate heaters and may be a cause of decreased efficiency of the distribution in the system.

Convectors are mostly located in the niche under the windows, following the Polish construction requirements. According to [1], system efficiency equals 89%.

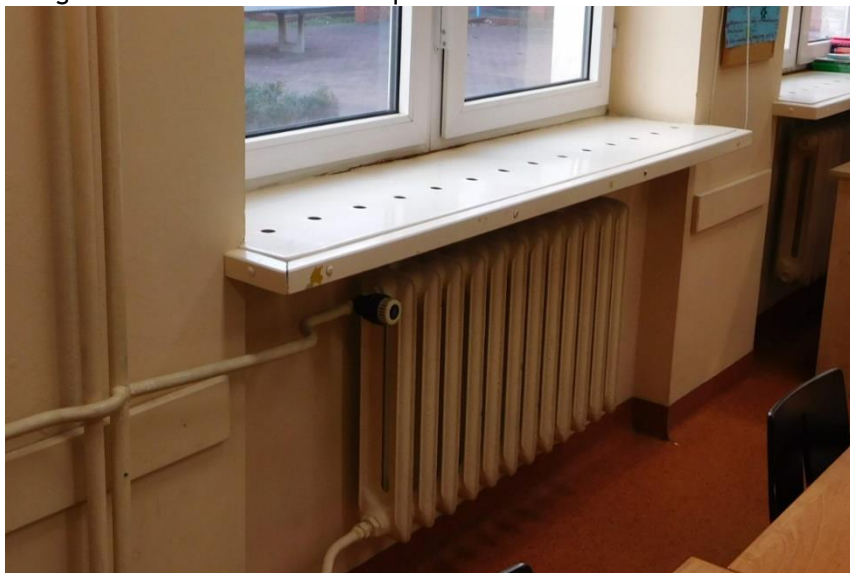
*Figure 36 Convectors in classrooms*

classrooms there are no shields. The temperature regulation in classrooms according to information gained during the audit is good and thermal comfort is well preserved. Convectors are located in the niche under the windows, following the Polish construction requirements.

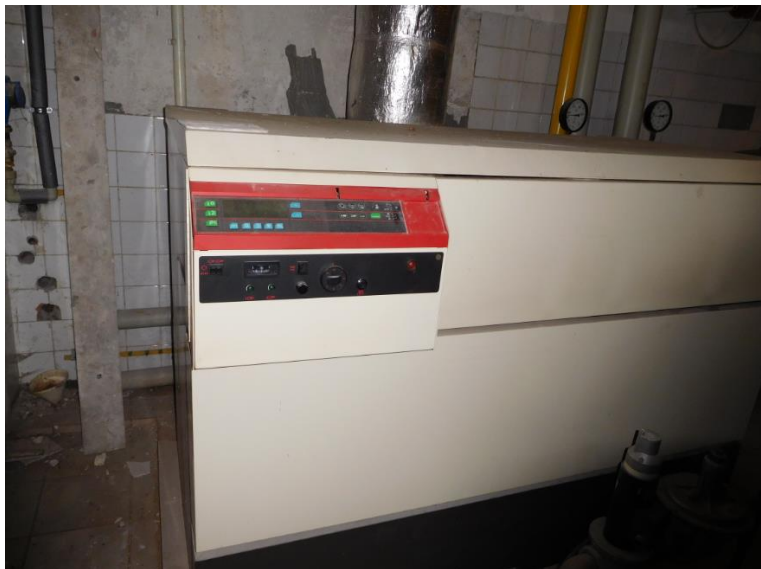
Heat for the building is produced with a traditional gas boiler. Heating factor parameters are 80/60°C. The designed heating load of the building calculated according to documentation is 300.1 kW. The boiler is located in non-heated basement room that has a separate entrance from the outside. The boilers (DeDietrich) heat capacity ranges from 189 to 300 kW, and the declared efficiency equals 90%. There is an accumulation tank in the system (500 dm<sup>3</sup>), which allows the boiler to work with a nominal capacity most of the time.

*Figure 39 Heating source in the building*

The actually installed boiler will be exchanged in the upcoming season with a condensing gas boiler (Bosch model Condens 700 F). The new boiler has already been bought, and it is waiting for summer to be installed.

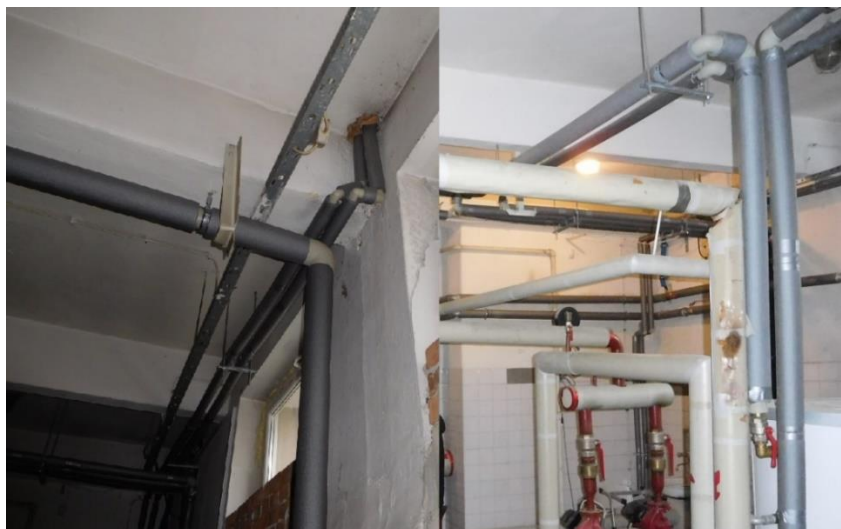
*Figure 40 Insulated pipes*

The insulation is in poor condition, many parts of pipes are lacking a thermal insulation, the boiler room is not heated, so heat loss through pipes is huge. According to [1] overall system efficiency equals 90%.

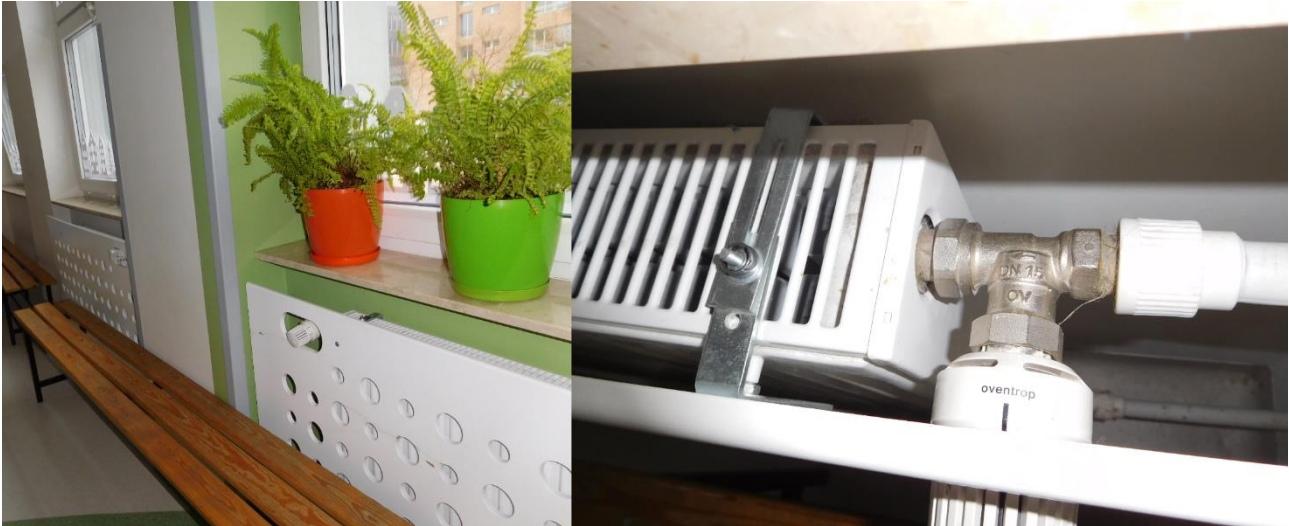
*Figure 41 Water convectors with thermostatic valves*

allow kids to get burn when the system is working. This however decreases the efficiency of radiant heating of plate heaters, and may be cause of decreased efficiency of distribution in the system.

Convectors are mostly located in the niche under the windows, following the Polish construction requirements. According to [1], the overall system efficiency equals 89%.

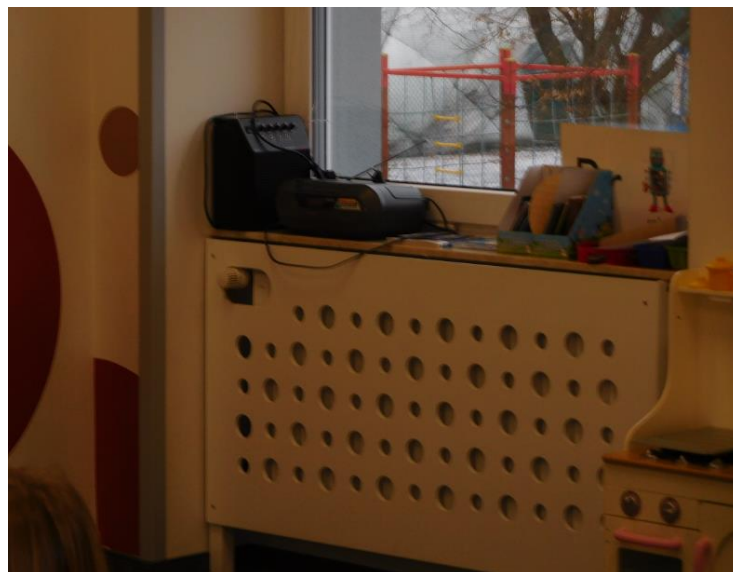
Water convectors in classrooms are the same as in the rest of the building, including thermostats, and shield with holes. As presented in the picture below, some of them are enclosed very tightly. A temperature regulation in classrooms according to information gained during the audit is good and thermal comfort is well preserved. Convectors are located in the niche under the windows, following the Polish construction requirements.

*Figure 42 Convectors in classrooms*

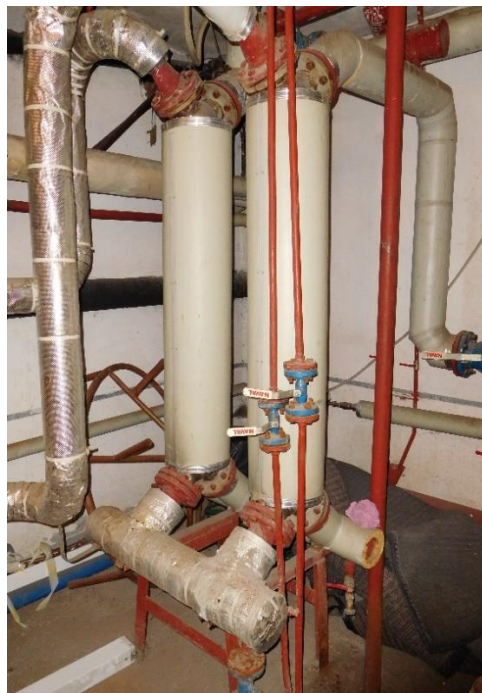
*Figure 49 Heating source in the building*

The heating source in the building is a traditional heat exchanger “JAD” type with weather control. The designed heating load for the building is 376 kW. The central heating installation works on parameters 85/60°. Water is the heating factor in the installation. The heat exchanger station powered by district heating is insulated, so according to [1] its efficiency equals 99%.

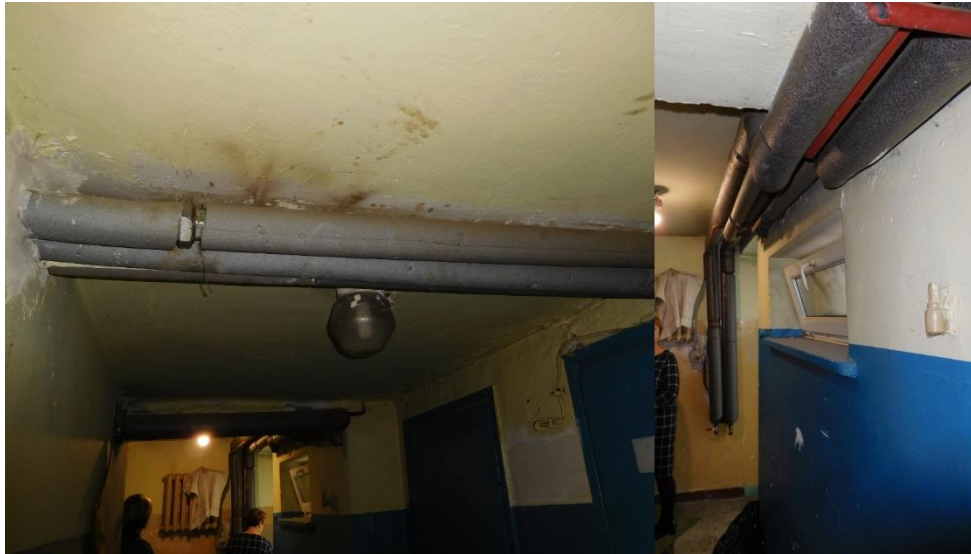
*Figure 50 Insulated pipes*

The heating source and some heating systems have been changed during modernization in 1994. Currently the heat exchanger cooperates with the insulated distribution system, supplying the central heating and domestic hot water systems. The insulation is maintained in the good condition. Basement where the heating source is located is also a heated space. According to [1] the overall system efficiency equals 96%.

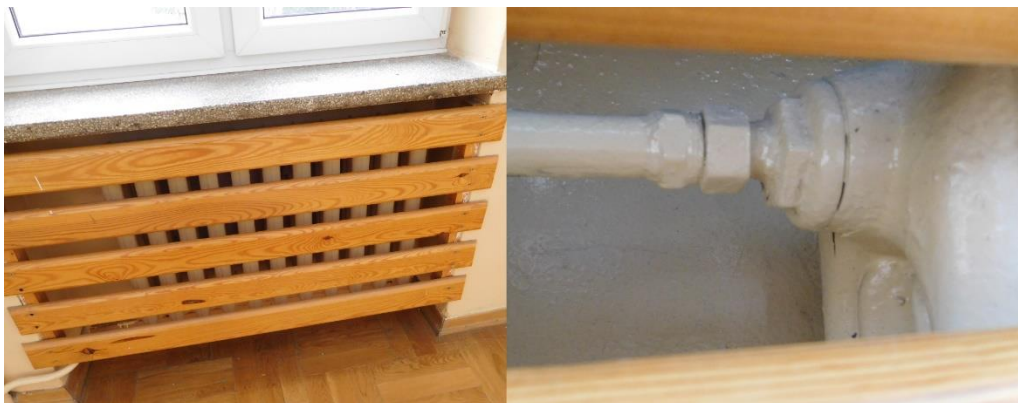
*Figure 51 Iron ribbed convectors in corridors*

Heaters in some zones has been exchanged during modernization in 1994. They are mostly located in the niche under the windows, following the Polish construction requirements. In the corridors there are old traditional iron ribbed radiators without thermostats, which causes overheating and eventually results in heat waste due to ventilation by frequent windows openings. According to [1] the overall system efficiency equals 77%.

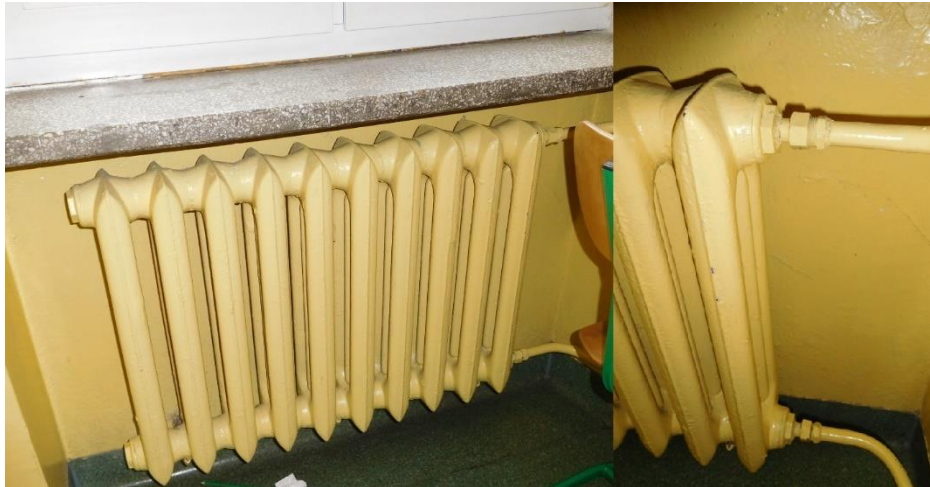
*Figure 52 Iron ribbed convectors in classrooms*

Radiators in classrooms are old traditional iron ribbed radiators without thermostats, which causes frequent overheating. There is only one central weather regulation in the heating source, so the only possible way for controlling temperature in classrooms is by opening the windows, which is usually done in order to improve thermal comfort in the classrooms. Radiators are located in niches under the windows, following the Polish construction requirements.

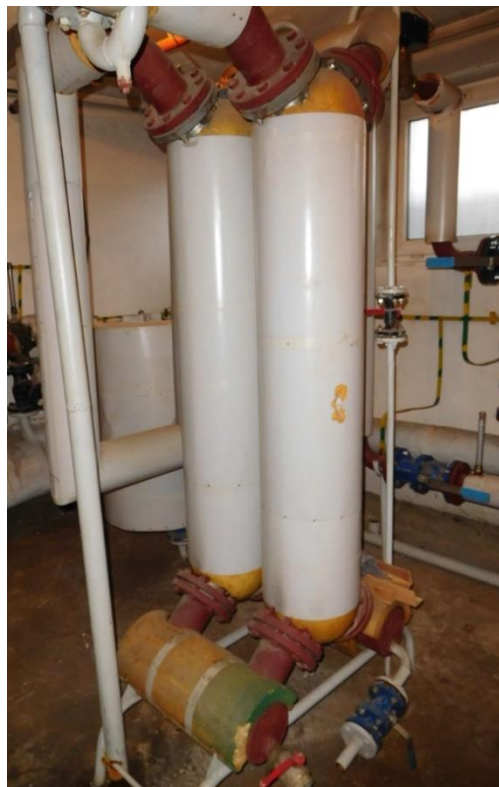
*Figure 59 Heating source in the building*

The heating source in the building is a traditional heat exchanger “JAD” type with weather control. Heat capacity ordered for the building is 285 kW. The central heating installation works on parameters 85/60°. Water is the heating factor in the installation. The heat exchanger station powered by the district heating is insulated, so according to [1] its efficiency equals 99%.

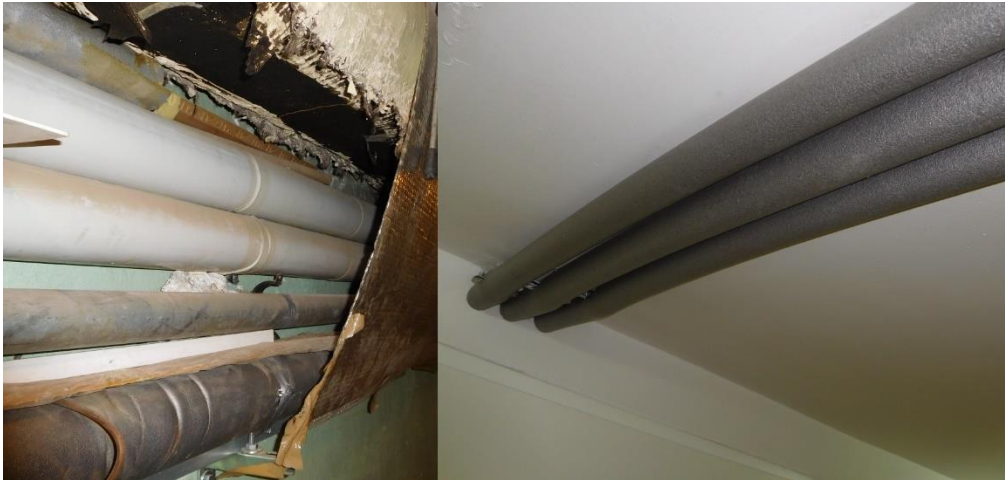
*Figure 60 Insulated pipes*

The heating source has been modernized in 1980. Currently the heat exchanger cooperates with insulated distribution system, covering central heating and domestic hot water for the building. The insulation is maintained in good condition. A basement where the heating source is located is also a heated space. According to [1], the system efficiency equals 96%.

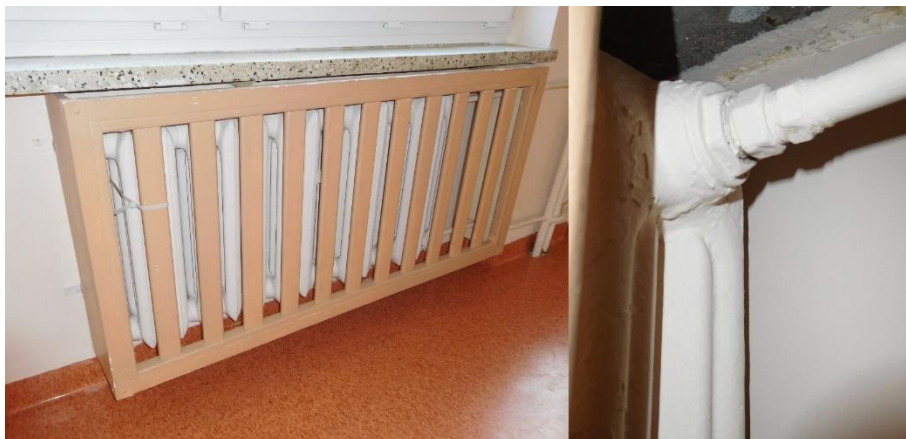
Heaters are mostly located in the niche under windows, following the Polish construction requirements. There are old traditional iron ribbed radiators without thermostats in the building. According to [1] the system efficiency equals 77%.

*Figure 61 Iron ribbed convectors in corridors*

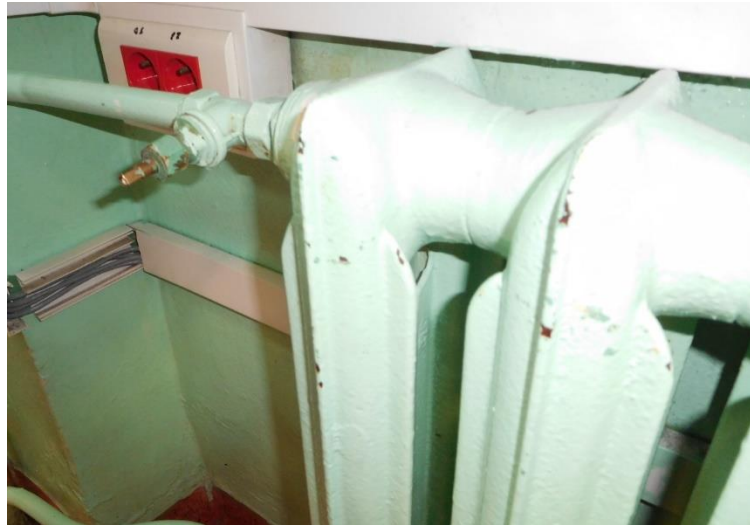
There are old traditional iron ribbed radiators without thermostats in classrooms. There is only a central weather regulation in the building and one heating control schedule in the heating source, so the only possible way for controlling temperature in classrooms is by opening the windows, which is usually done in order to improve thermal comfort in classrooms. Radiators are located in niches under the windows, following the Polish construction requirements.

*Figure 62 Iron ribbed convectors in classrooms*

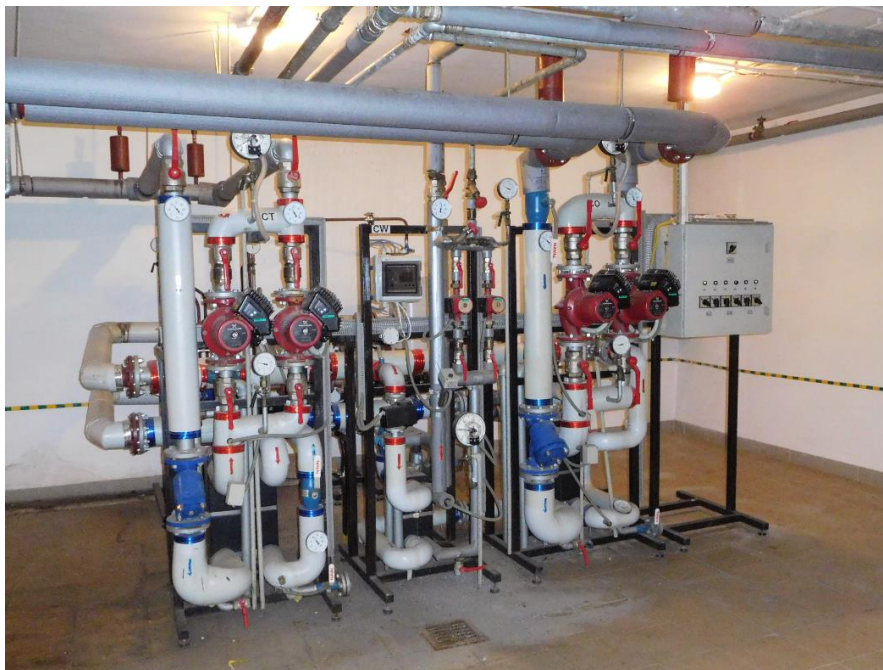
*Figure 70 The heating source in the building*

The heating source in the building is a compact type heat exchanger with weather control. The designed heating load for the building is 475 kW. It is assumed that the central heating installation works on parameters 85/60°C. Water is the heating factor in the installation. The heat exchanger station powered by the district heating is insulated, so according to [1] its efficiency equals 99%.

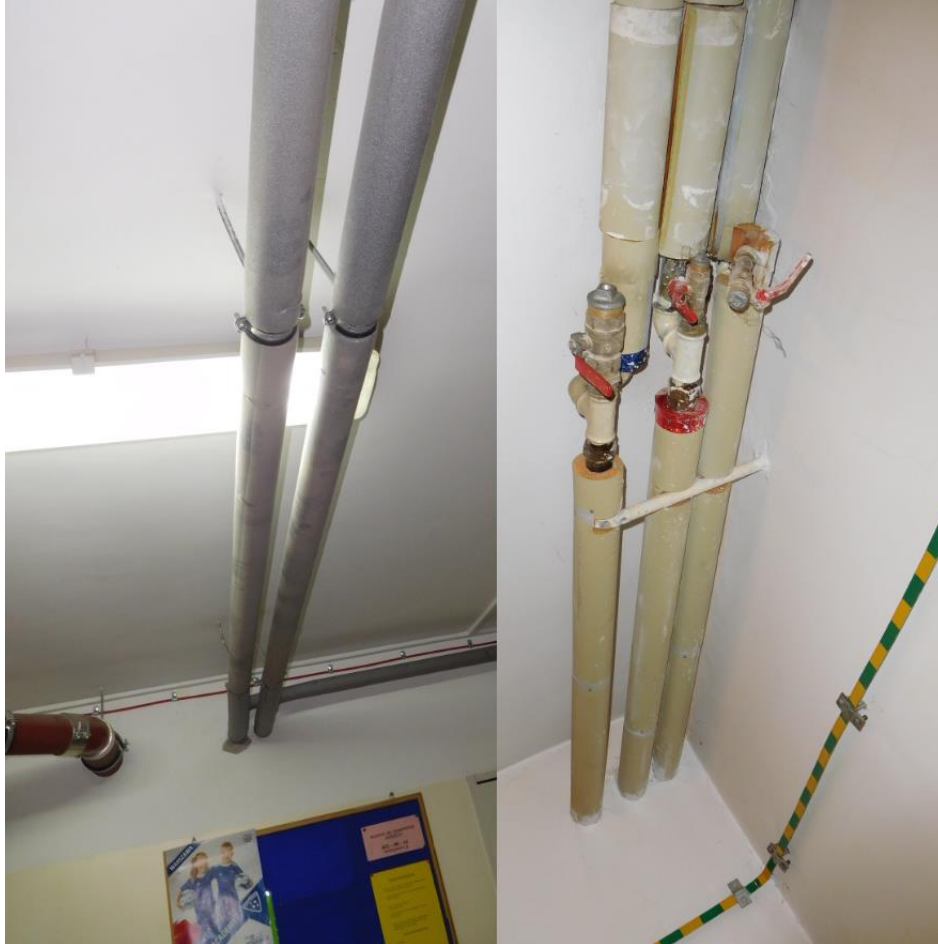
*Figure 71 Insulated pipes*

The insulation is maintained in a good condition. A basement where the heating source is located is also a heated space. According to [1] the system total efficiency equals 96%.

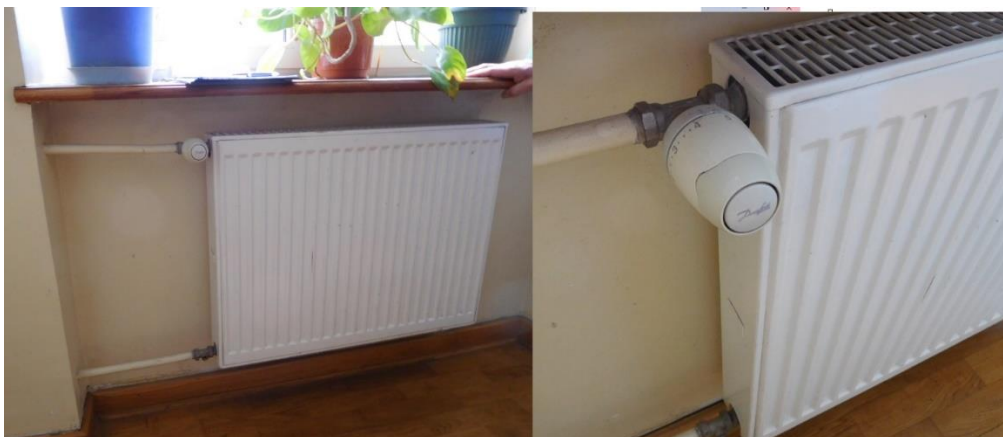
*Figure 72 Water convectors with thermostatic valves*

Heat is distributed by water convectors equipped with thermostatic valves. They are mostly located in niches under the windows, following the Polish construction requirements. According to [1], the overall system efficiency equals 89%.

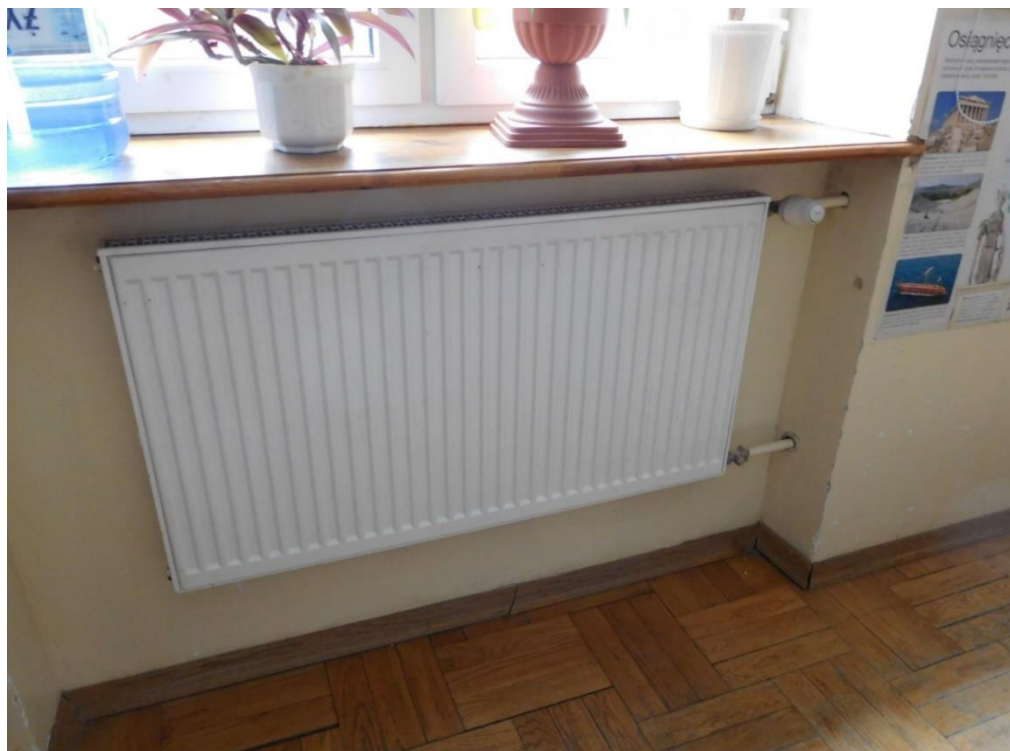
Water convectors in classrooms are the same as in the rest of the building, including thermostats. A temperature regulation in classrooms, according to information gained during the audit, is good and thermal comfort is well preserved. Convectors are located in the niches under windows, following the Polish construction requirements.

*Figure 73 Convectors in classrooms*
